Case Study: Skye ? a very unlucky dog indeed!

Skye is a lovely working Border Collie, who was unfortunately run over by a JCB in January 2019.

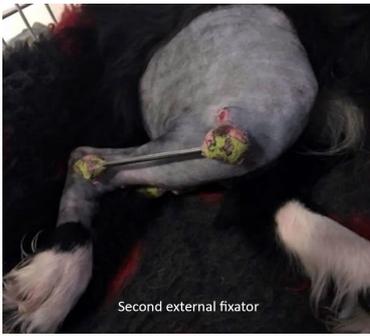
The external fixator, seen in the pictures below, is made up of pins inserted into the intact parts of the bone above and below the fractured section. These are held together with metal clamps and connecting bars to create a solid cage around the limb, preventing movement of the broken pieces and so allowing the bone to heal.

She had a comminuted (bone broken into lots of pieces) fracture of her tibia (or shin bone). This was repaired with an external fixator to hold all the bones together while they healed.

Unfortunately a fracture like this takes a long time to heal, and despite amazing care from her owners, Skye had some complications. The first was to rupture her cruciate ligament on the same leg in April. This injury makes the knee joint unstable and does require fixation, but this could not be done until the fracture had healed and all the implants were removed. The second problem was due to the long healing process, the implants, which loosen over time, needing replacing with new pins, to create a smaller fixator in May as the fracture had not fully healed.

By June, all the implants were removed as the fracture had healed well.
